Confidential Inspection Report

**Prepared by Bill Weitzel
Central PA Home Inspections
Carlisle, PA 17013
www.centralpahomeinspections.com**

INSPECTION
SITE: 100 New St.

INSPECTION
SITE CITY/STATE/
ZIP: Newtown, PA 17000.

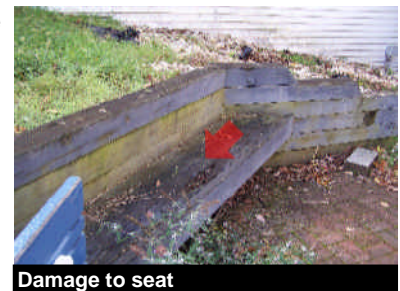
Damage to seat

Rot and or deterioration is noted at one or more locations at the bench area. Repairs suggested.

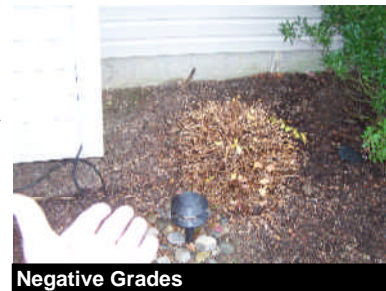
Flat site. Negative grades noted at one or more locations. Evidence of poor drainage. Pitch slope of soils away from foundation. Slope should fall away from the foundation at a minimum of 1/2 inch per foot and extend at least 10 feet away from the foundation. The soil and or mulch is covering some of the siding. Any wood that is behind this siding will be prone to rot. This will also create an environment that could allow termite activity.

Negative Grades

"Inspectors Tip" The best defense against water seepage into the basement or crawl space is good drainage of soils near the foundation at a minimum of 1/2 inch per foot and extend at least 10 feet away from the foundation.

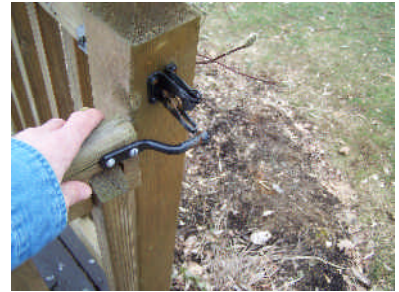
Appears serviceable. The fencing appears to be in satisfactory condition. Gate needs minor repair or adjustments.

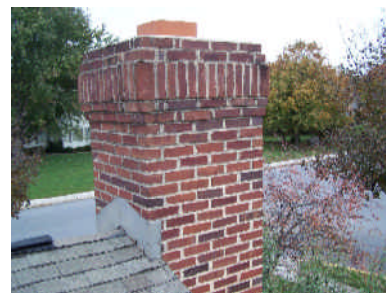
CONDITION: Appears serviceable. The chimney appears to be **lined**. Flue appears serviceable. Cracks were observed at the chimney cap. We suggest all cracks of the chimney cap be patched or repaired as needed. [There are certain portions of the chimney that are not visible from the roof at the chimney or interior from the fireplace and therefore not available for a complete evaluation during a normal home inspection.](#) [Complete chimney inspection is **NOT** a part of this inspection.](#) We Strongly suggest cleaning and a complete chimney certification of all chimneys before taking possession of the property.

[All chimneys should be lined.](#) We suggest installing a liner into any and all unlined chimneys. All chimneys should be fitted with spark arrester, and appliance vents should be capped. Birds and animals like to sit on flues and build their nests in them. Sometimes they are overcome by fumes and fall down in the flue causing a serious backup of carbon monoxide. *"A list of Certified Chimney Sweeps is available on the net at www.ncsq.org or www.csia.org"*

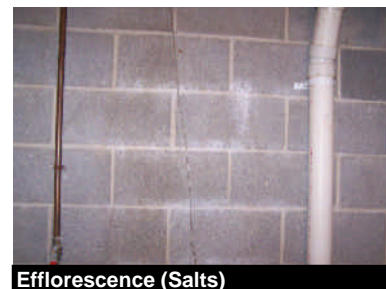
Efflorescence (Salts)

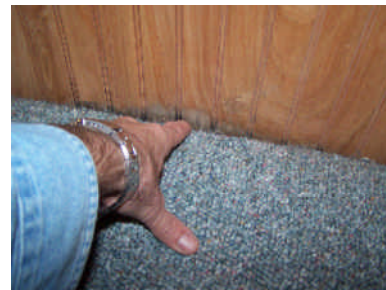
Appears serviceable. Typical cracks noted. Staining was observed at one or more locations. Evidence of prior water penetration is noted. Efflorescence seen on walls indicates the presence of periodic moisture. Full viewing of the foundation walls is restricted by wall coverings and prevent a full inspection of foundation walls. Deterioration noted to foundation walls is minor. The best defense against water seepage is good drainage of soils near the foundation wall.

"Inspectors Tip" This condition may vary seasonally and/or with precipitation intensity. Lot drainage improvements should be addressed as the first step to controlling water in the basement or crawl space areas. Roof gutters should be clear of leaves or debris that can cause overflowing of gutters. Grades should be corrected at the exterior of the home. Downspouts should be routed at least (10) feet away from the building.

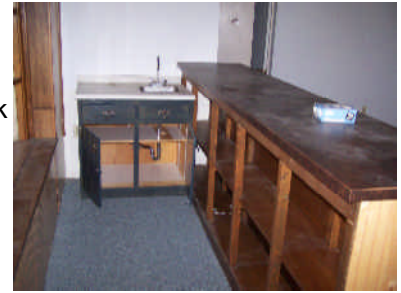
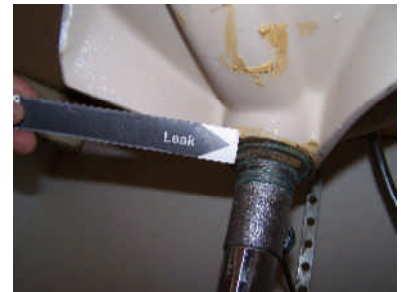
There is a wet bar in the finished portion of the basement. All plumbing and associated systems were operated and found to be in working order. However there was a small leak in waste line. Counters and cabinets are functioning as intended with minor wear.

Sink has minor leak. Repair as needed.

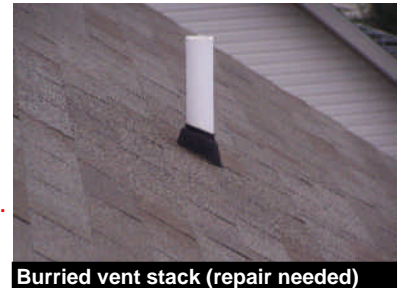
Metal. Rubber. **Repair Needed:** One of the vent flanges on roof is not properly installed. Repair is suggested. Attic sheathing and attic insulation in attic was wet at the time of the inspection. We suggest that a qualified licensed roofing contractor should be called to make further evaluation and repairs as needed.

Burried vent stack (repair needed)

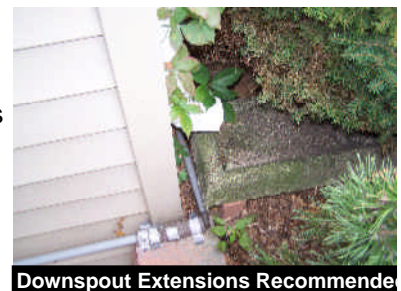
Full, Appears serviceable, Route downspouts away from the building. Roof water should be drained a minimum of eight feet away from the foundation. Further is better. Subsurface drains noted, but not tested. **THEY ARE NOT PART OF THIS INSPECTION.** We do however suggest that they are evaluated for function.

Downspout Extensions Recommended

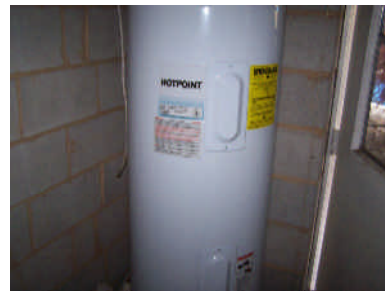
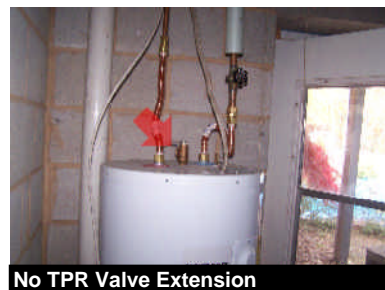
Pressure relief valve noted, not tested. Pressure relief valve drain line is missing or ends prematurely. This is a SAFETY HAZARD. We suggest this drain line be extended to a safe location. A qualified plumber should evaluate and repair as needed. This unit is an older appliance. Life expectancy is difficult to predict. The estimated service life of an electric water heater is 20 years.

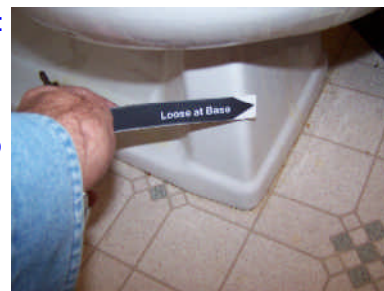
The following problems were noted at the toilet: Toilet is loose at floor. A new wax seal should be installed under loose toilets and should be re-mounted to closet flange with the proper bolts. Minor plumbing repairs will be needed to restore proper operation. We suggest that a qualified licensed plumber evaluate and make repairs as needed.

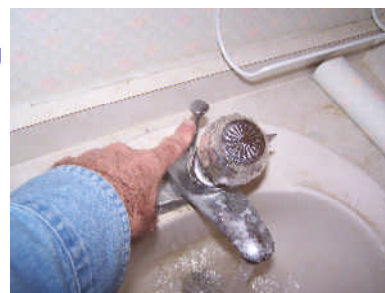
Bathroom sink. Appears serviceable. There is minor wear noted to the cabinets. The following problems were noted at the drain: Stopper did not operate properly. Repair is suggested.

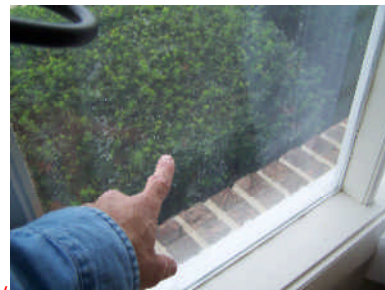
Sliding, Casement, thermal insulated, clad-metal/vinyl, windows were observed. Three sets of Bay windows were observed. [The Bay windows at multiple locations were observed to show symptoms of a breach seal or failure between two pieces of glass. This often takes the form of condensation or staining between the panes of an insulated glass unit. We suggest full evaluation of all the bay windows by a qualified appropriate contractor with repair/replacement as needed.](#)
