Confidential Inspection Report

**Prepared by Bill Weitzel
Central PA Home Inspections
Carlisle, PA 17013
www.centralpahomeinspections.com**

INSPECTION
SITE: 100 New St.

INSPECTION
SITE CITY/STATE/
ZIP: Newtown, PA 17000.

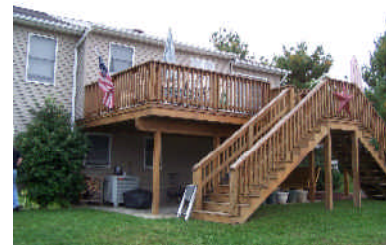
Rear, Wood (pressure treated)

Appears serviceable.

"Inspector Tip" Proper care and maintenance will be needed to protect the deck surface and wood members from deterioration. Periodic cleaning and treatment with a stain preservative is suggested throughout ownership.

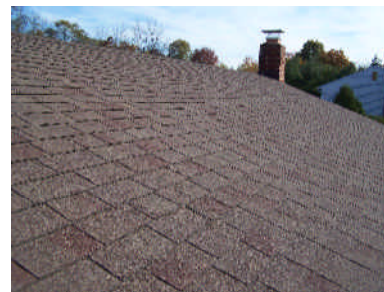
Gable roof.

The roof covering for this structure was Composition shingles. **Asphalt/fiberglass roofing shingles** generally have service lives of 20-25 years for conventional and Architectural style 30-50 years respectively in this area of the country.

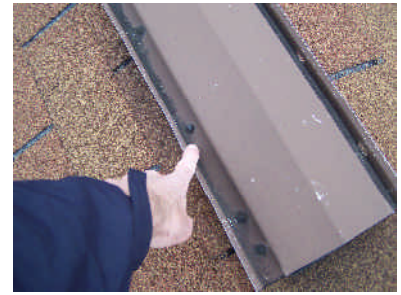
Metal. Rubber. **Repair Needed:** One of the vent flanges on roof is not properly installed. Repair is suggested. Attic sheathing and attic insulation in attic was wet at the time of the inspection. We suggest that a qualified licensed roofing contractor should be called to make further evaluation and repairs as needed.

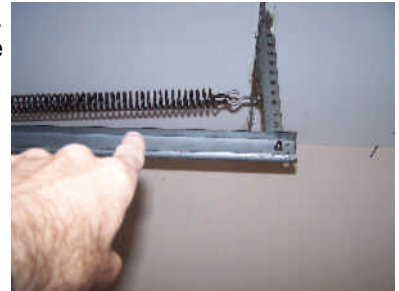
CONDITION: The overhead garage doors are made of wood. Automatic door opener(s) is operational. There is an electronic eye installed on this garage door and is functioning as intended. Automatic reverse feature, operational, Safety cables should be installed to the garage door overhead door springs. .

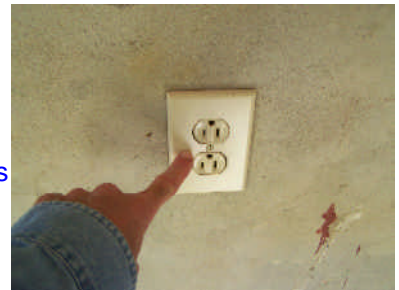
The receptacles in the garage have GFCI protection. The GFCI reset for the garage receptacles is located in the garage.

"Inspectors Tip" There is one receptacle in the garage that does not have GFCI protected. This receptacle is intentional should be used for additional refrigerator or freezer needs. This receptacle will not have a chance to get tripped in the event of wet conditions or accidental short. Flammable materials or liquids should not be stored within closed garage areas.

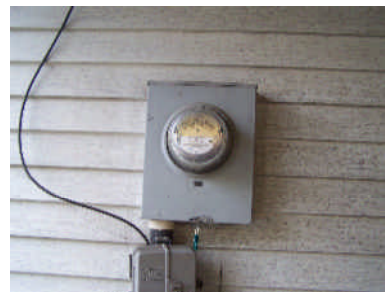
Underground. 120/240 Volt. 200 amp service.
Circuit breakers.

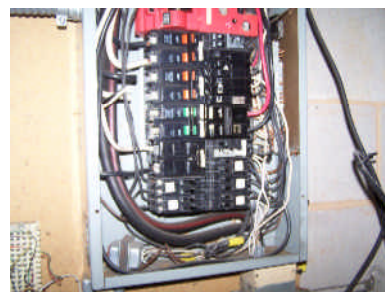
Basement.

Circuit and wire sizing correct so far as visible, Grounding system is present.
Bonding OK.

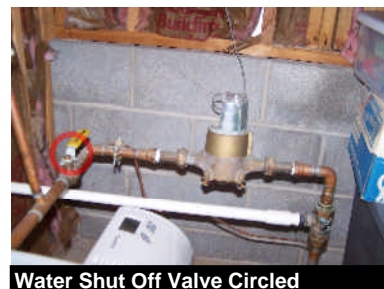
The main line is 3/4 inch in diameter. Copper, Meter and the water main shut off was observed to be in the basement South wall.

Water Shut Off Valve Circled

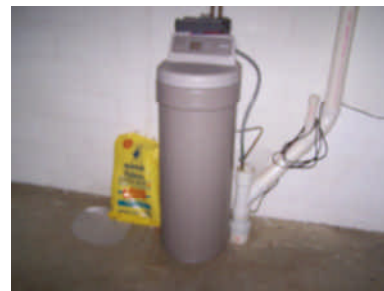
A water treatment system was installed into the buildings water supply. The softener was not inspected and is not a part of a standard home inspection. Have the seller demonstrate the proper operation of this component.

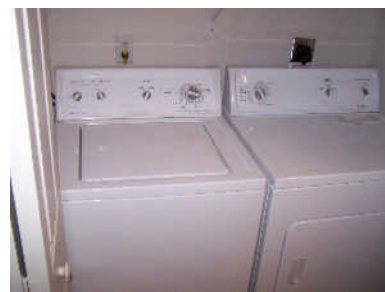
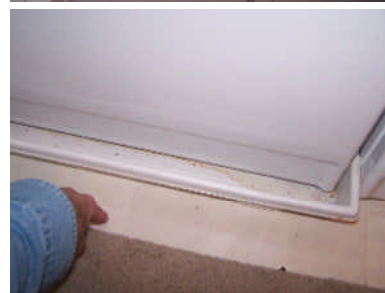
Electrical outlet is grounded. 240 Service-operational. Plumbing appears serviceable. The washing machine and dryer was not fully tested. A pan was installed but was unable to evaluate it's effectiveness and or it's drain line and termination point. [We suggest a proper watertight pan be installed under washing machines in any second floor laundry room. This pan should have a drain line that terminates properly to an indirect waste line or exterior location.](#)
